# B10-807 DJØIP

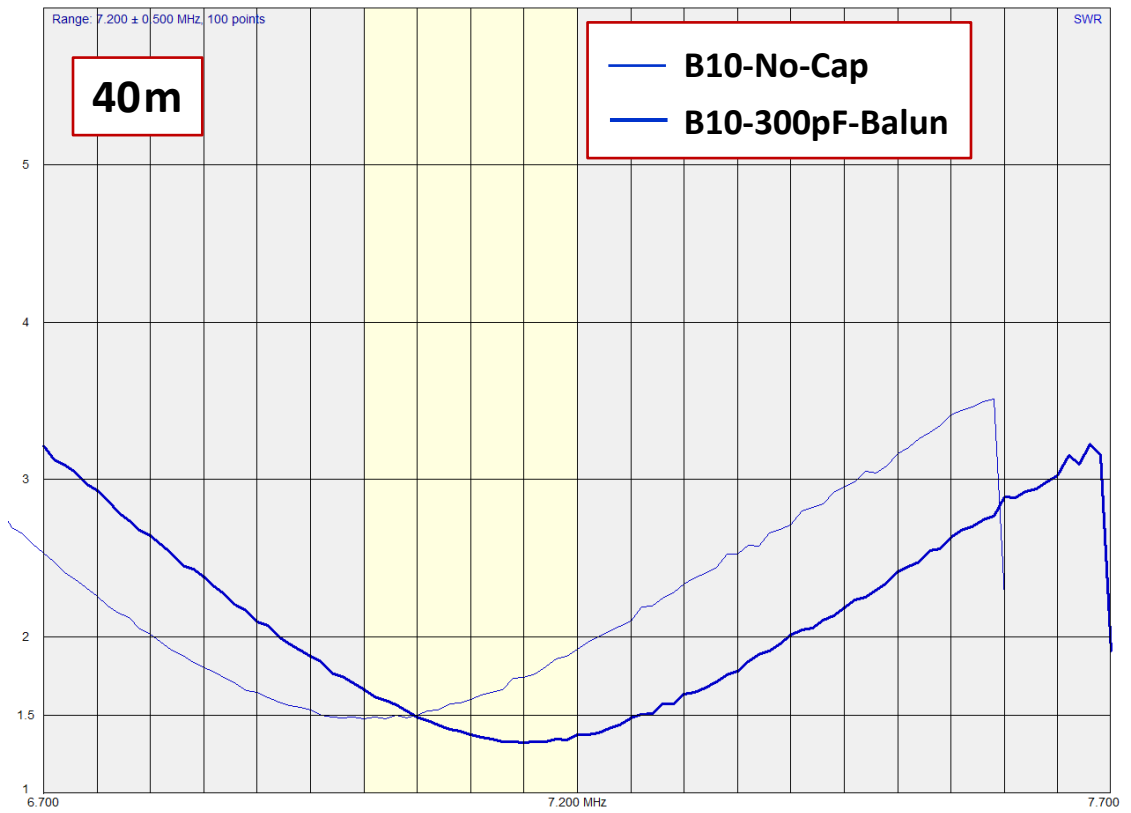
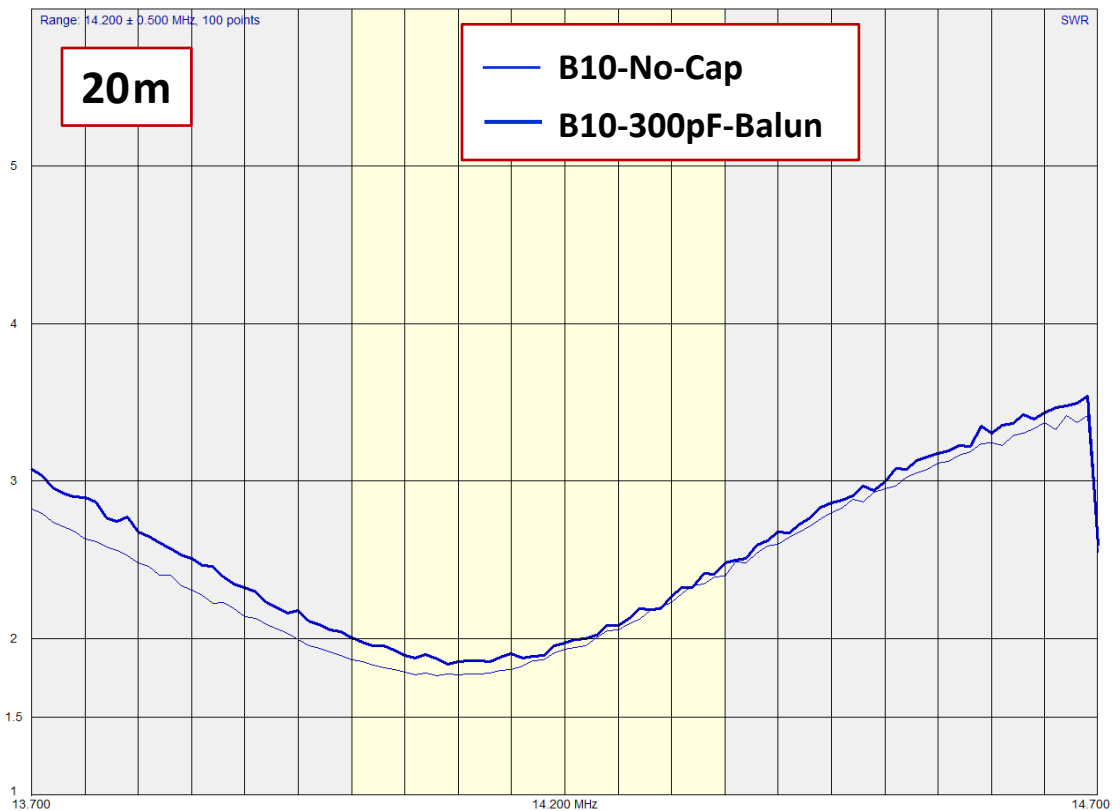
For some reason beginning with 20m, the signal becomes very jagged. The entire group of 300 pF (Balun) tests needs to be repeated with a different 300 pF capacitor.

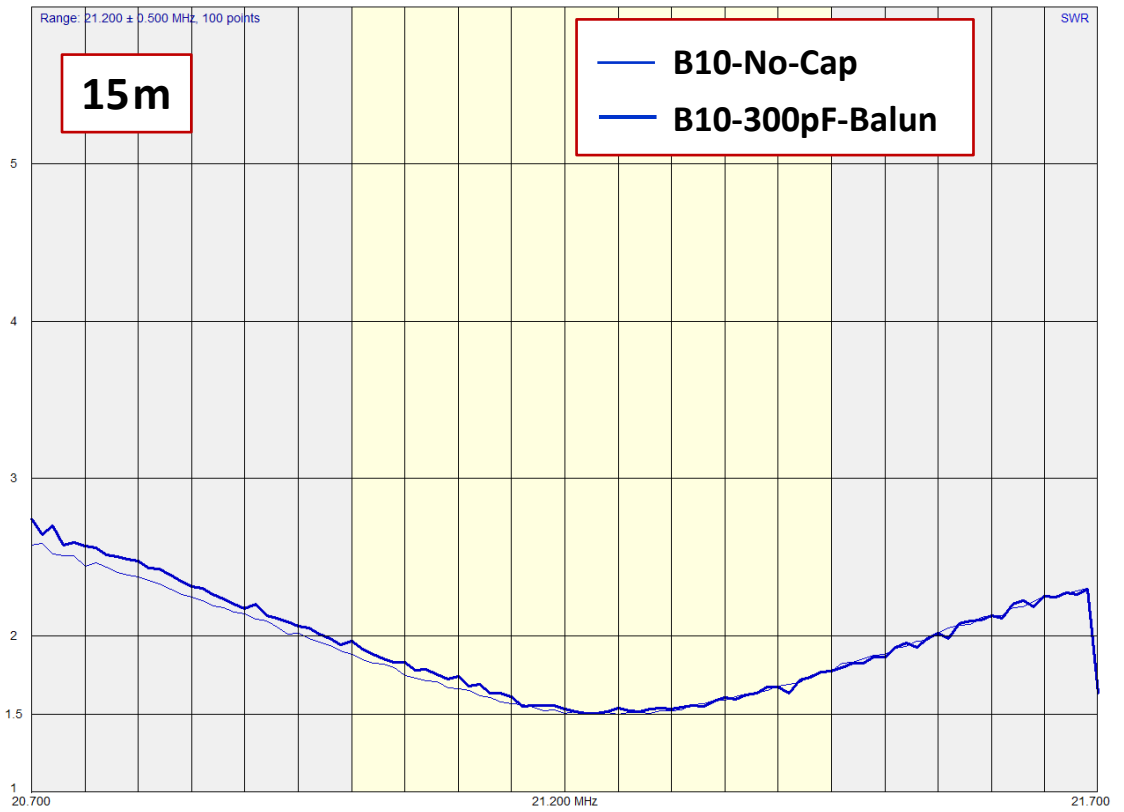
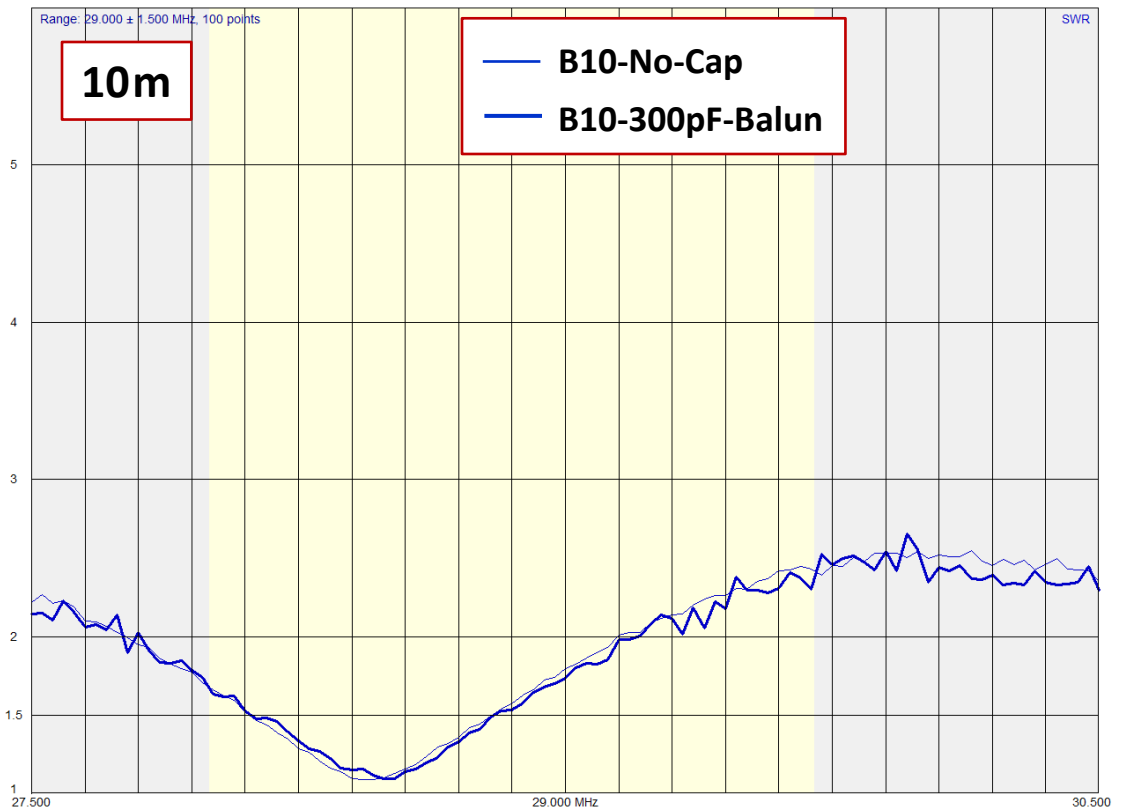
Though 15m looks almost OK, 10m looks awful!

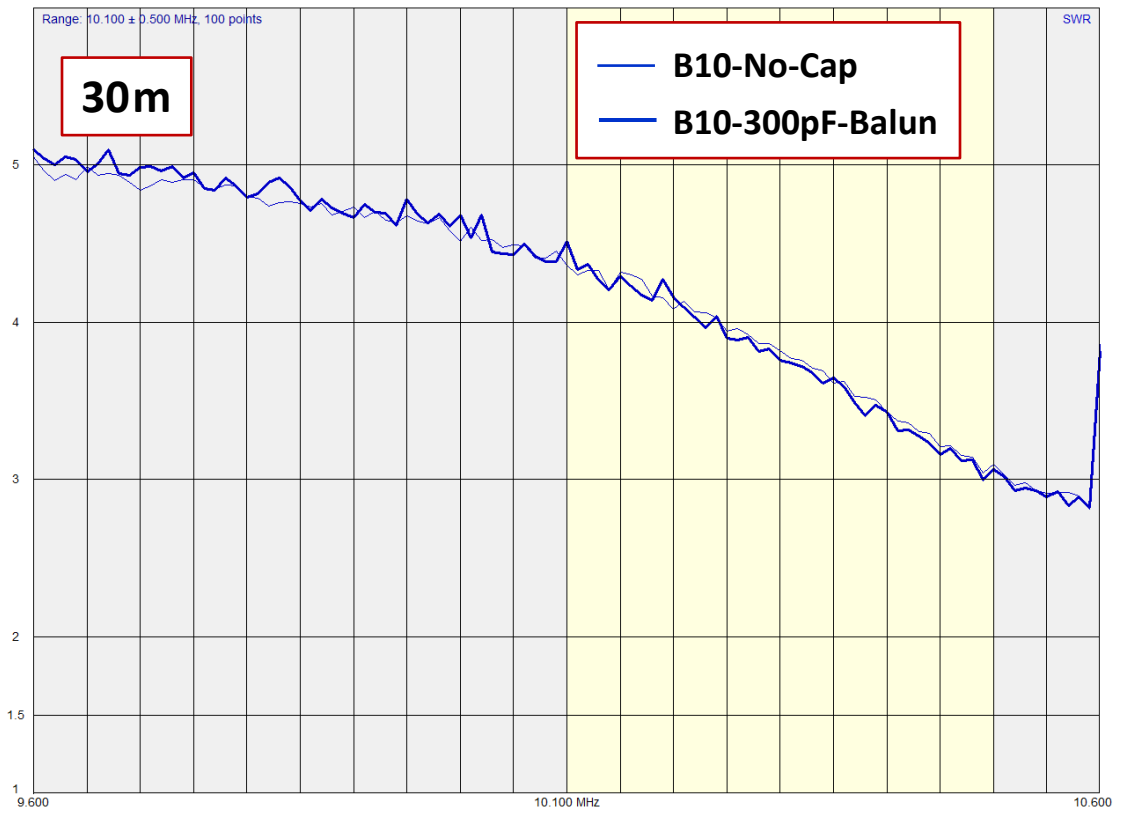
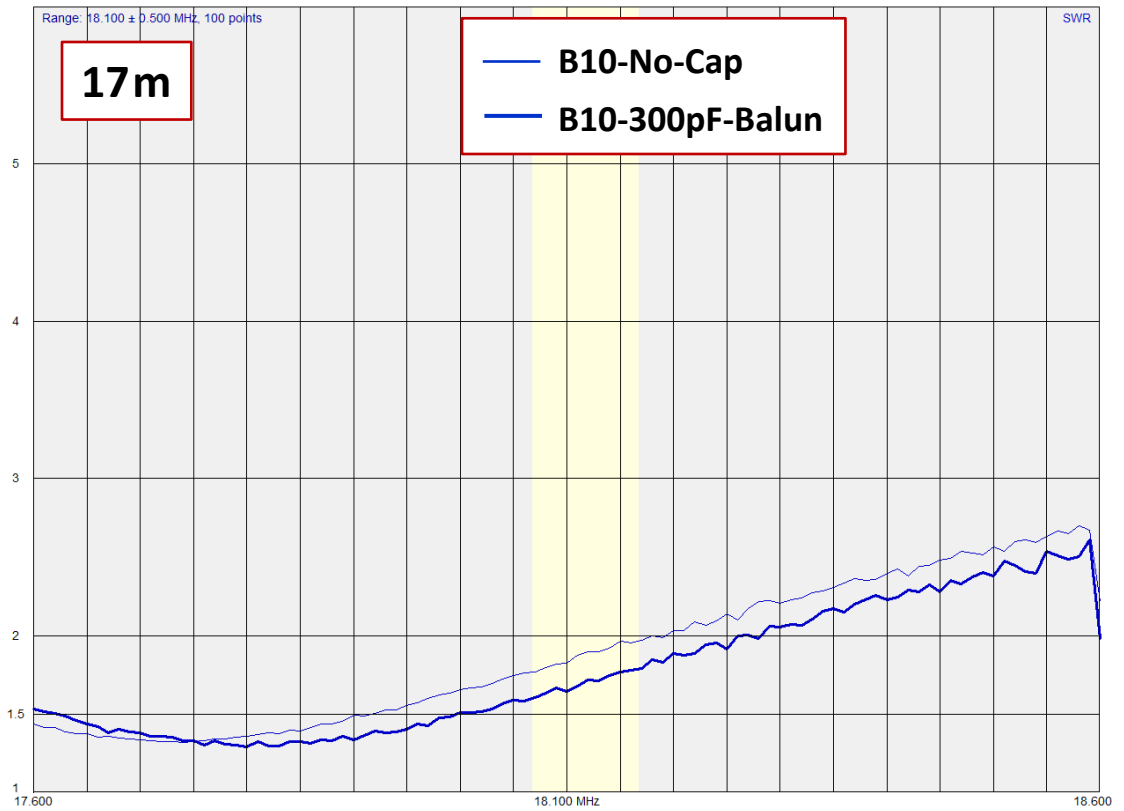
Here both bands look jagged.

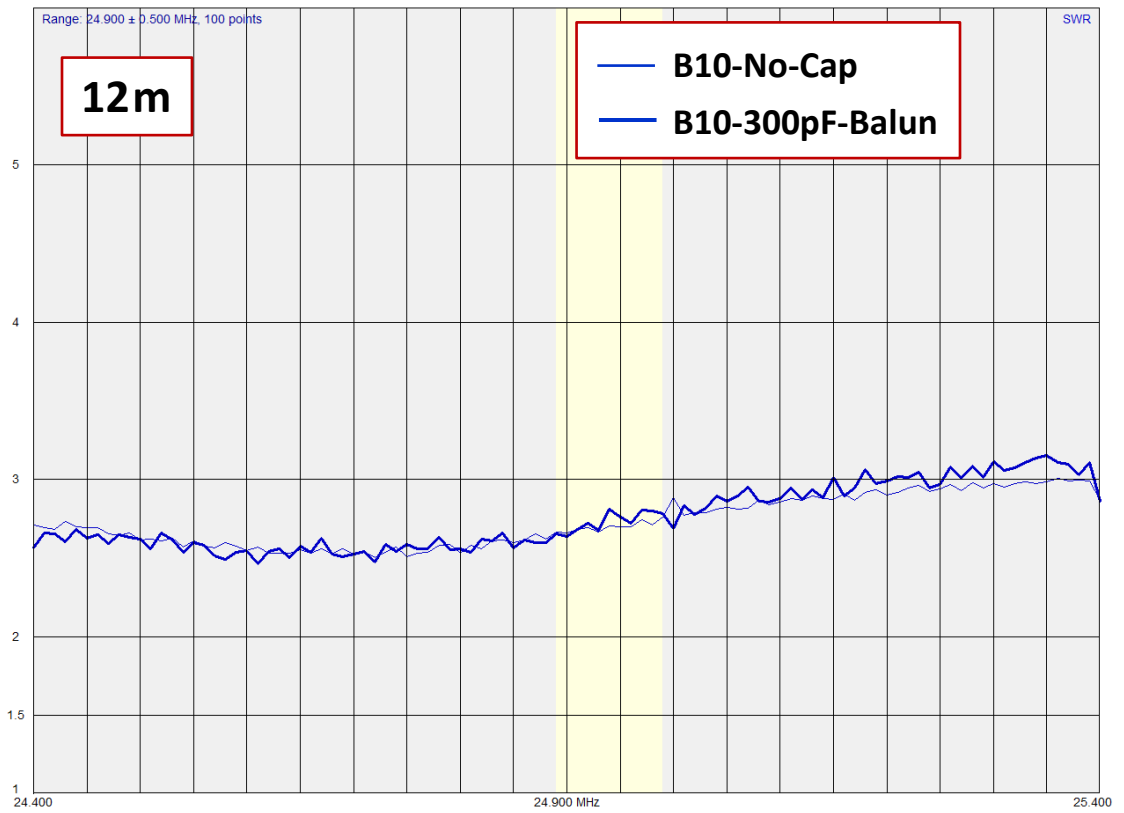
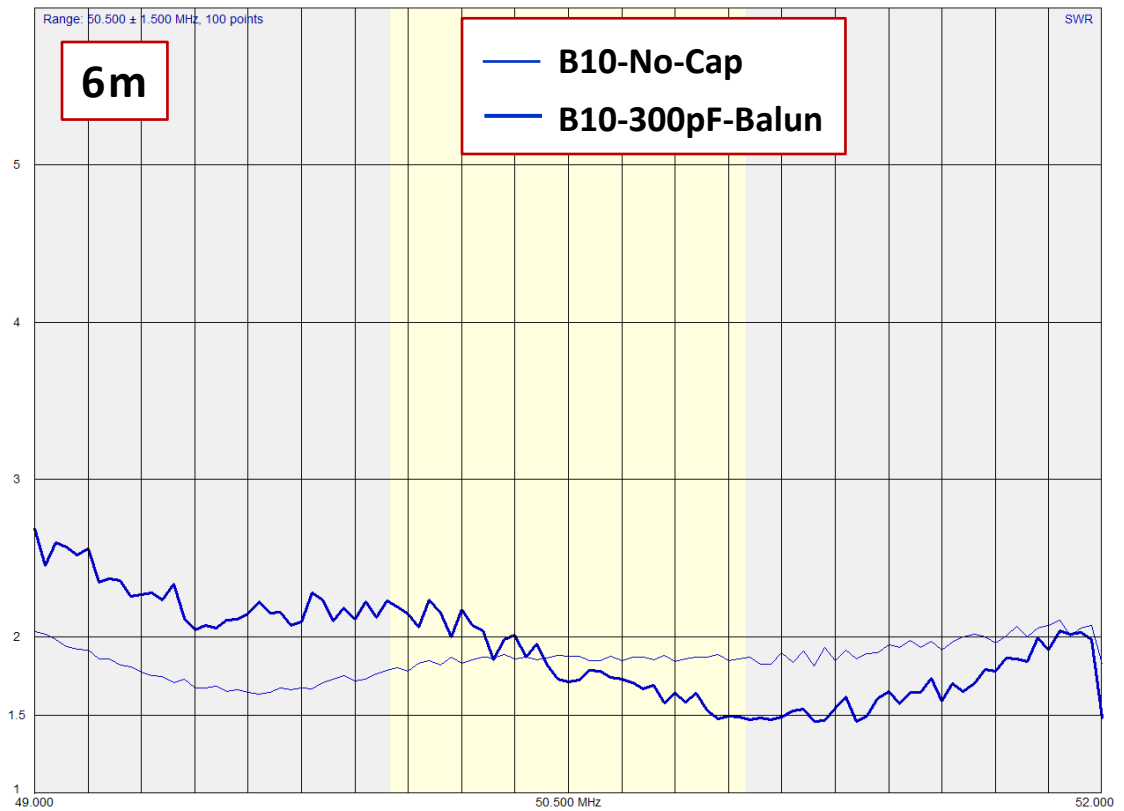
The jagged curves continued on these bands too.
